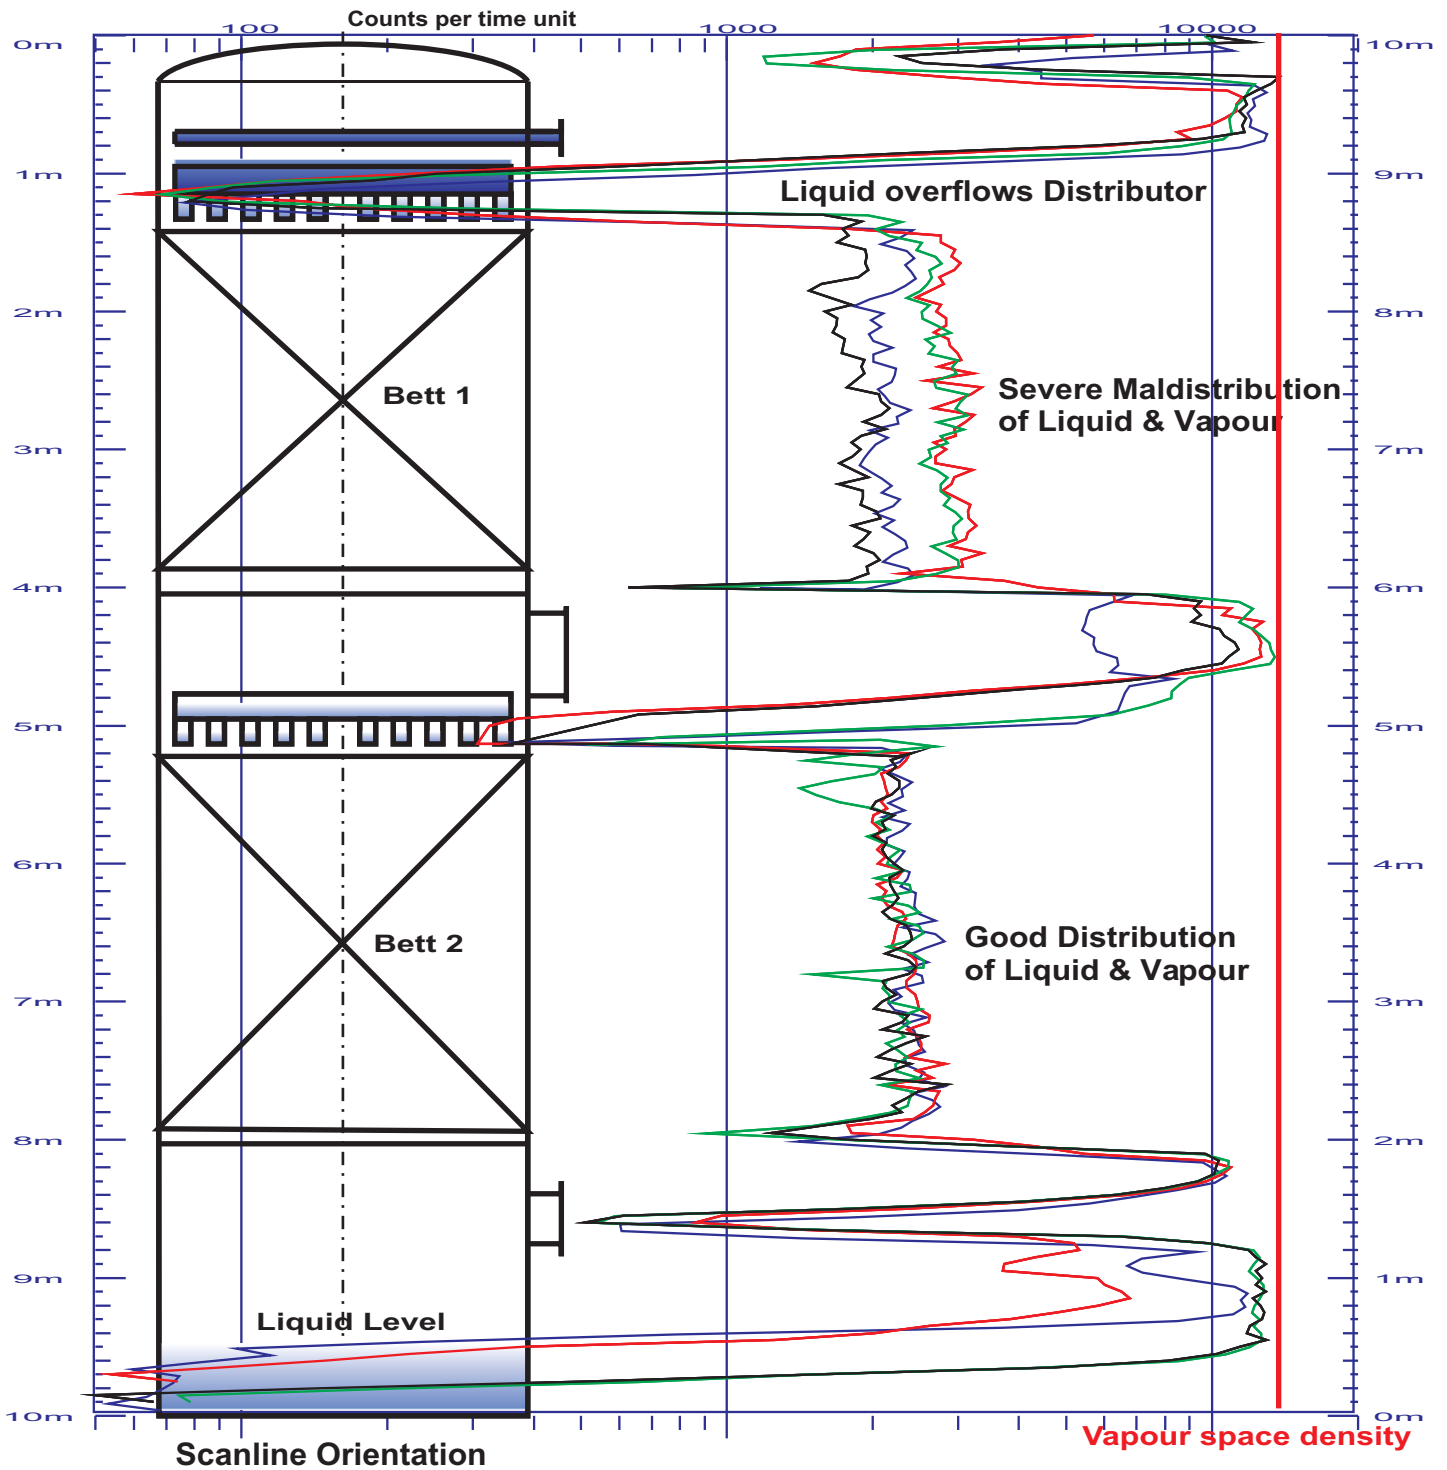
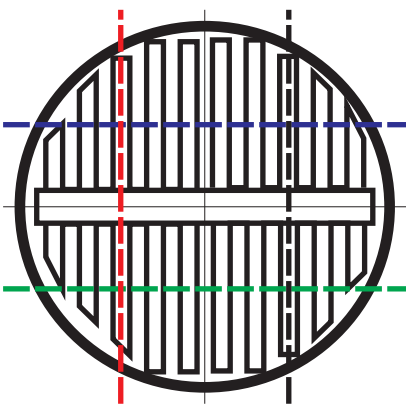
Both liquid distributors have same design / construction. Distributor of bed 1 is overflowing and generates severe maldistribution of liquid / vapour in the bed. The drip holes were partially plugged due to debris in the reflux pipe during start up. Distributor of bed 2 is working proper. It is possible to measure the liquid levels in parting box and distribution troughs. The distribution of phases is quite good across cross section and height of bed 2.
